Remanufactured OEC 6800 Mini C-arm

EDI OEC 6800 Mini C-arm Remanufacturing Process

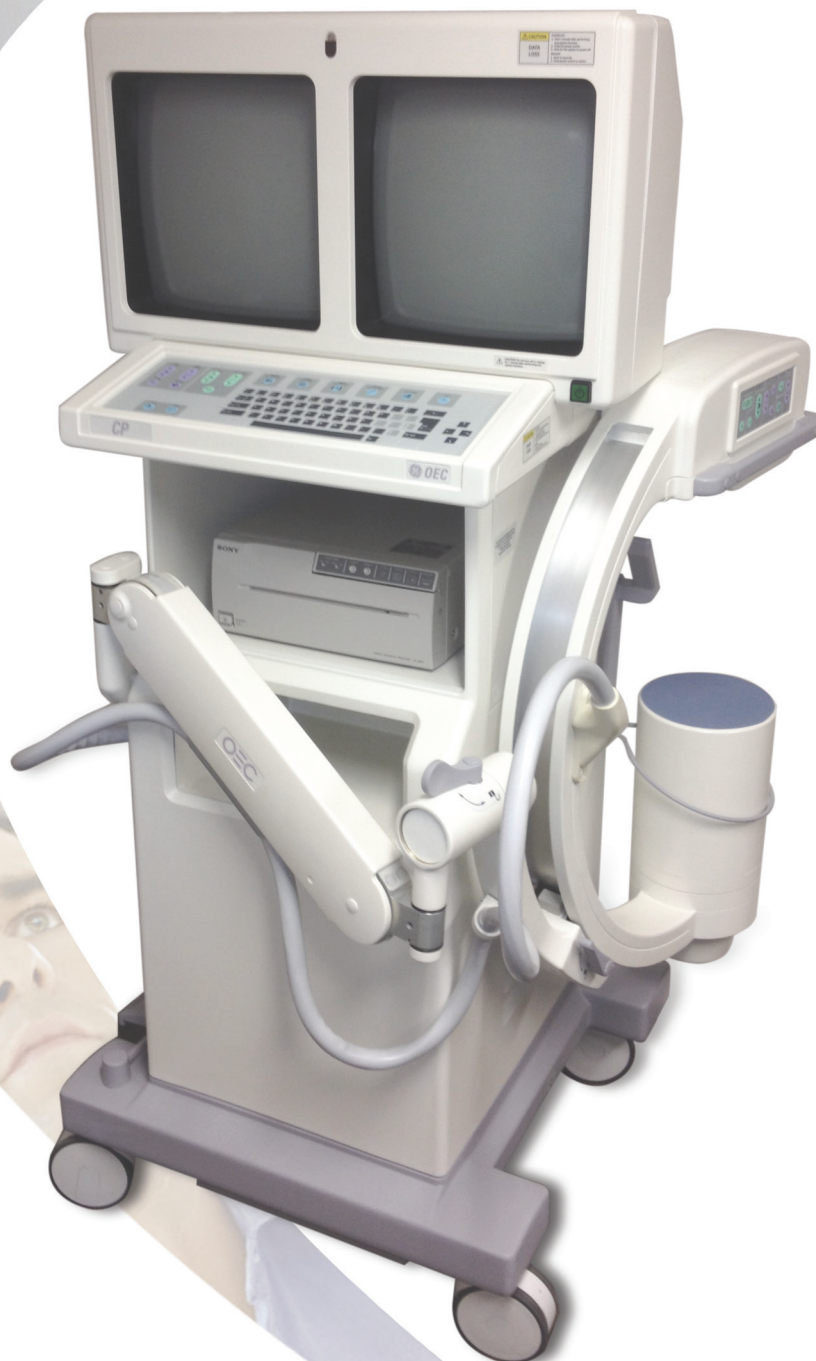
The 1Kx1K CCD camera technology used in the OEC 6800 image system allows for crisp, clear imaging. For whatever the purpose, an EDI remanufactured OEC 6800 will deliver the results you can depend on.

- Free Space: 12"
- Depth: 14.5"
- SID: 14.9"
- Orbit Rotation: 110 degrees
- Rotation: +/- 200 degrees
- Wig-Wag: 180 degrees
- Vertical Travel: 24"
- Extension: Up to 55"
